WANAQUE GRADIENT  
CORROSION CONTROL  
REVIEW – INITIAL DRAFT

**City of Newark**  
Lead and Copper Rule Compliance Study  
Wanaque Gradient

City of Newark Department of  
Water and Sewer Utilities

February 1, 2019

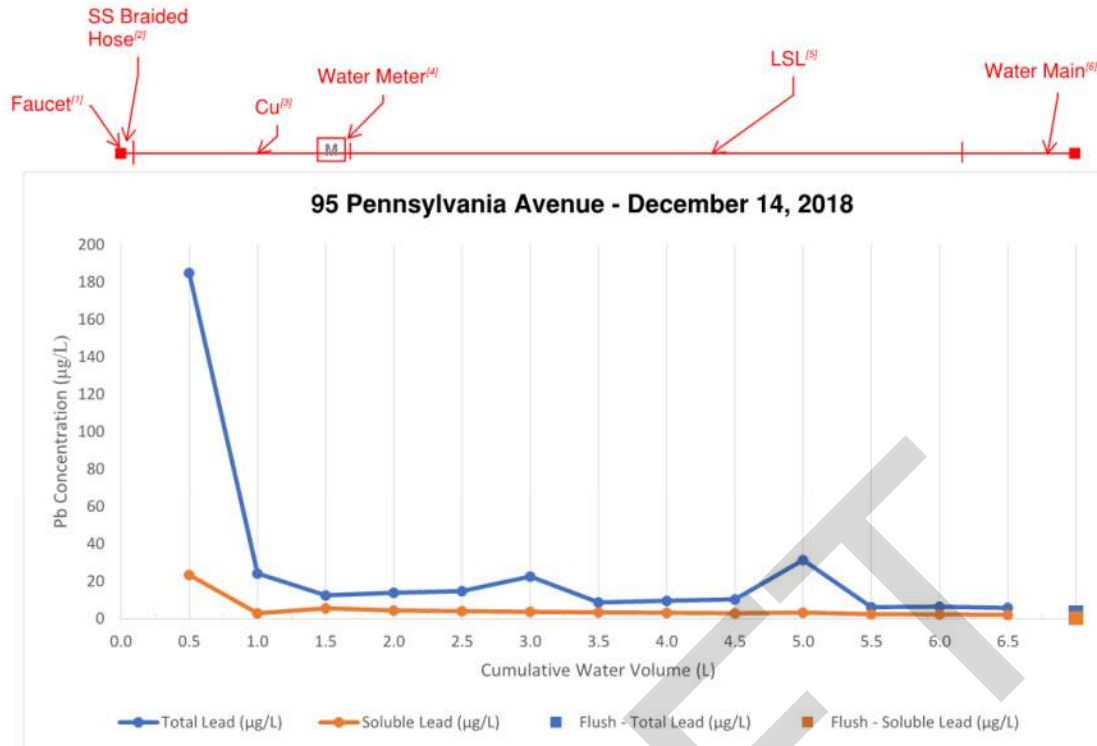
**Figure 4-2 – 95 Pennsylvania Avenue Lead Profile – December 14, 2018**

It was estimated that 95 Pennsylvania Avenue needed thirteen (13) 500 mL samples to encompass the entire interior plumbing and service line prior to reaching the main. This home had a lead service line and lead solder with copper indoor plumbing and was sampled before the lead service line replacement (LSLR) and after the LSLR. A portion of the lead service line was sent to the EPA for a scale analysis following the first sequential sampling event. The following are the observations for the lead profile and water quality results for 95 Pennsylvania Avenue, as shown in **Tables 4-1 and 4-2 and Figures 4-2 and 4-3**.

- The highest lead levels at this address were found in the interior plumbing components, including the faucet hosing and piping directly connected to the faucet. For the first sequential sampling, before the LSLR, soluble lead peaked at 23.4 µg/L and total lead at 185 µg/L in the first sample (on the faucet hosing and interior plumbing components). For the second sequential sampling (post LSLR), soluble lead peaked at 19.8 µg/L in the 12<sup>th</sup> sample and the total lead peaked at 108 µg/L in the first sample.

- Significant particulate lead was found at this address in the first draw samples in both sequential sampling events. For the first sequential sampling, the aerator was removed on site prior to collecting samples but after flushing and stagnation. For the second sequential sampling, the aerator was removed prior to flushing and the stagnation period and remained off until sampling was completed.

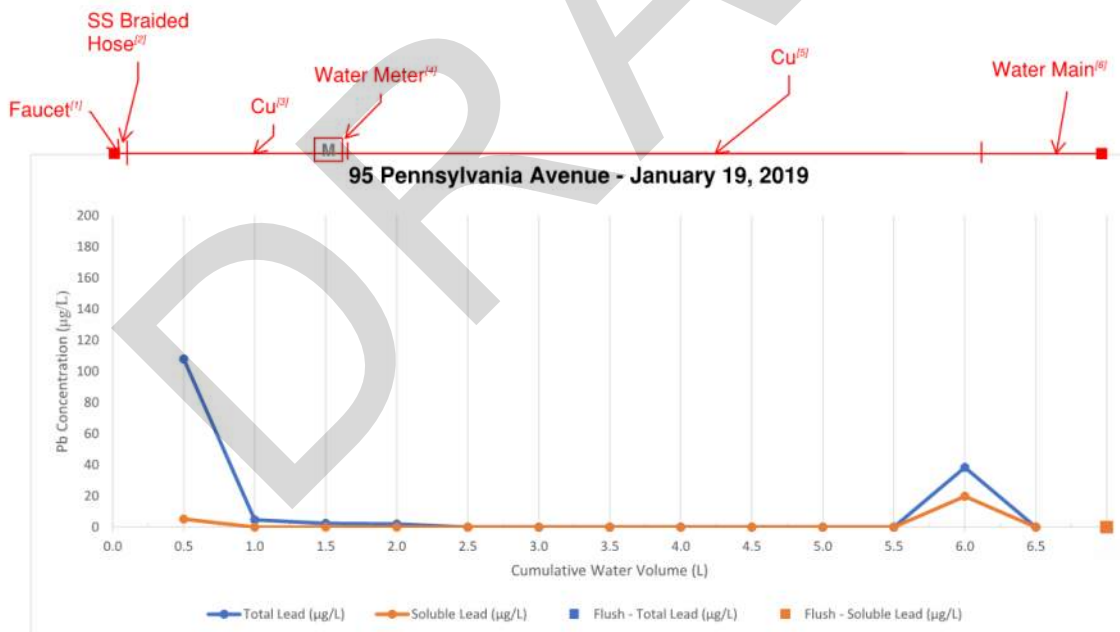
- After flushing the water at the faucet for 10 minutes, the soluble lead was non-detect (ND), and the total lead was 2.96 µg/L for the first sequential sampling. After the service line was replaced, both the soluble lead and total lead concentrations were ND in the flushed sample.

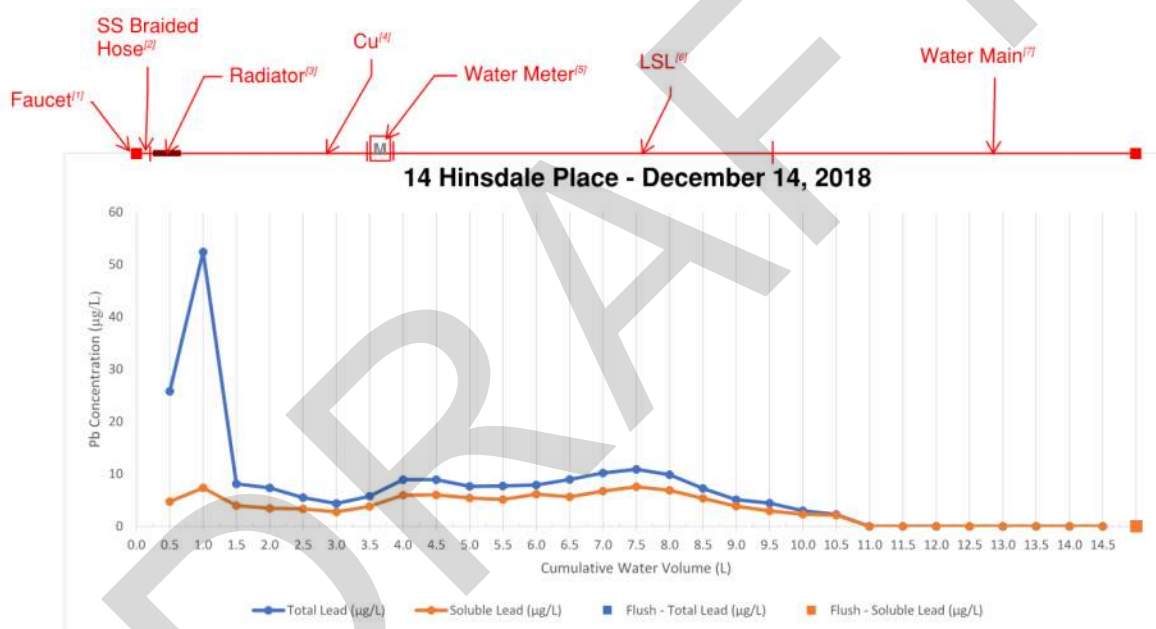
**Figure 4-4 – 14 Hinsdale Place Lead Profile – December 14, 2018**

It was estimated that 14 Hinsdale Place needed twenty (20) 500 mL samples to encompass the entire interior plumbing and service line prior to reaching the main. This home had a lead service line and did not have lead solder found on the copper indoor plumbing before the meter. This location was sampled before and after the LSLR. A portion of the lead service line was sent to the EPA for a scale analysis. The following are the observations for the lead profile results for 14 Hinsdale Place, as shown in **Tables 4-3 and 4-4** and **Figures 4-4 and 4-5**.

- The highest lead levels at this address were found in the interior plumbing components, including the faucet hosing and piping connected to the faucet. For the first sequential sampling, before the LSLR, the soluble lead peaked at 7.35 µg/L and total lead at 52.4 µg/L in the second sample (in the interior plumbing components after the faucet). For the second sequential sampling, after the LSLR, soluble lead peaked at 14.4 µg/L in the flushed sample and the total lead peaked at 17 µg/L in the fourth sample.
